**Surface Compliance of Coal Bed Natural  
Gas (CBNG) Development in North  
Central Wyoming**

**Benjamin E. Kniola  
Julian Serafin Gil  
November, 4 2005**

## **Abstract**

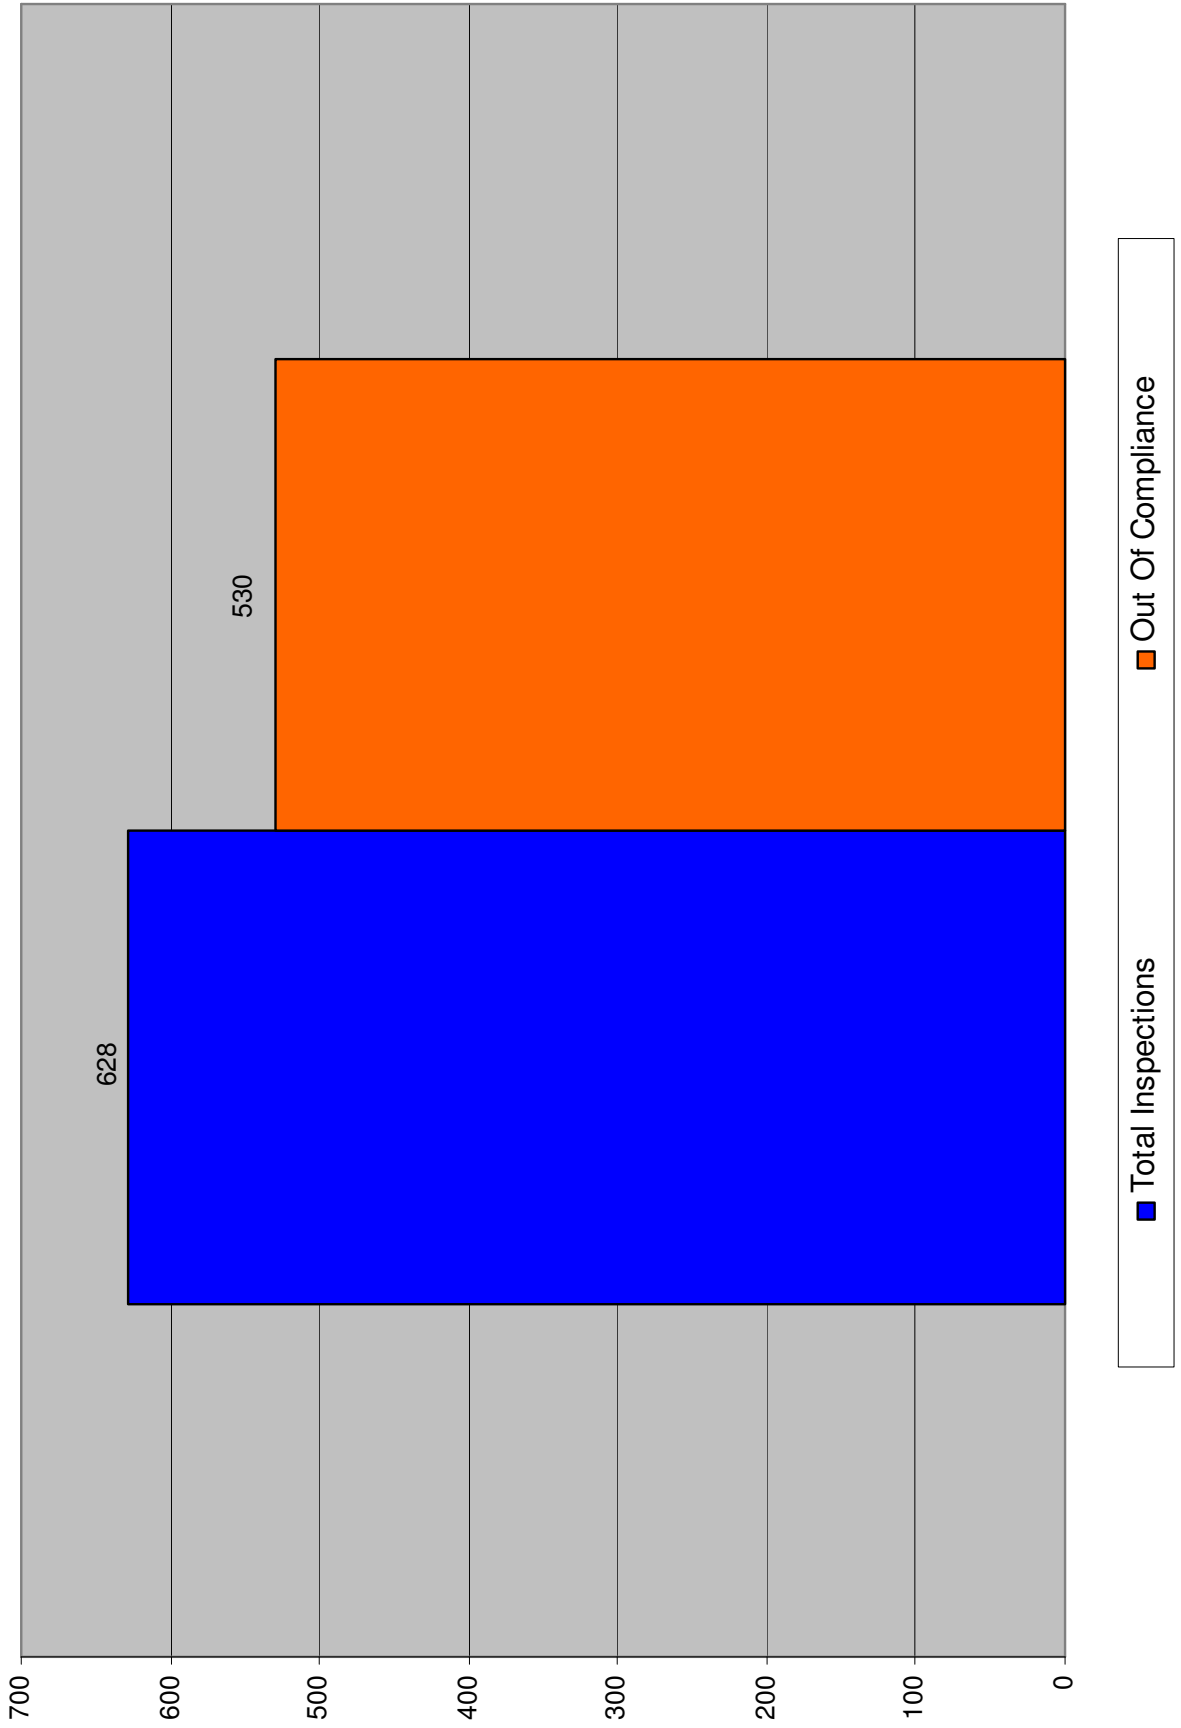
**Figure 3: Compliance Totals (Wells & Facilities)**

A total of 628 inspections were completed, including both wells and facilities. 530 of those wells and facilities were found to be out of compliance (Figure 3). A total of 43 enforcement actions were sent to operators; 34 Written Orders and 9 Incident of Non-Compliance letters. Full compliance in regards to wells (Figure 4) and/or facilities (Figure 5) was the case with 7 of 20 operators inspected, and only 1 of these operators was compliant with both wells (Figure 4) and facilities (Figure 5). On average all operators that were inspected were 84% out of compliance (Figure 6).

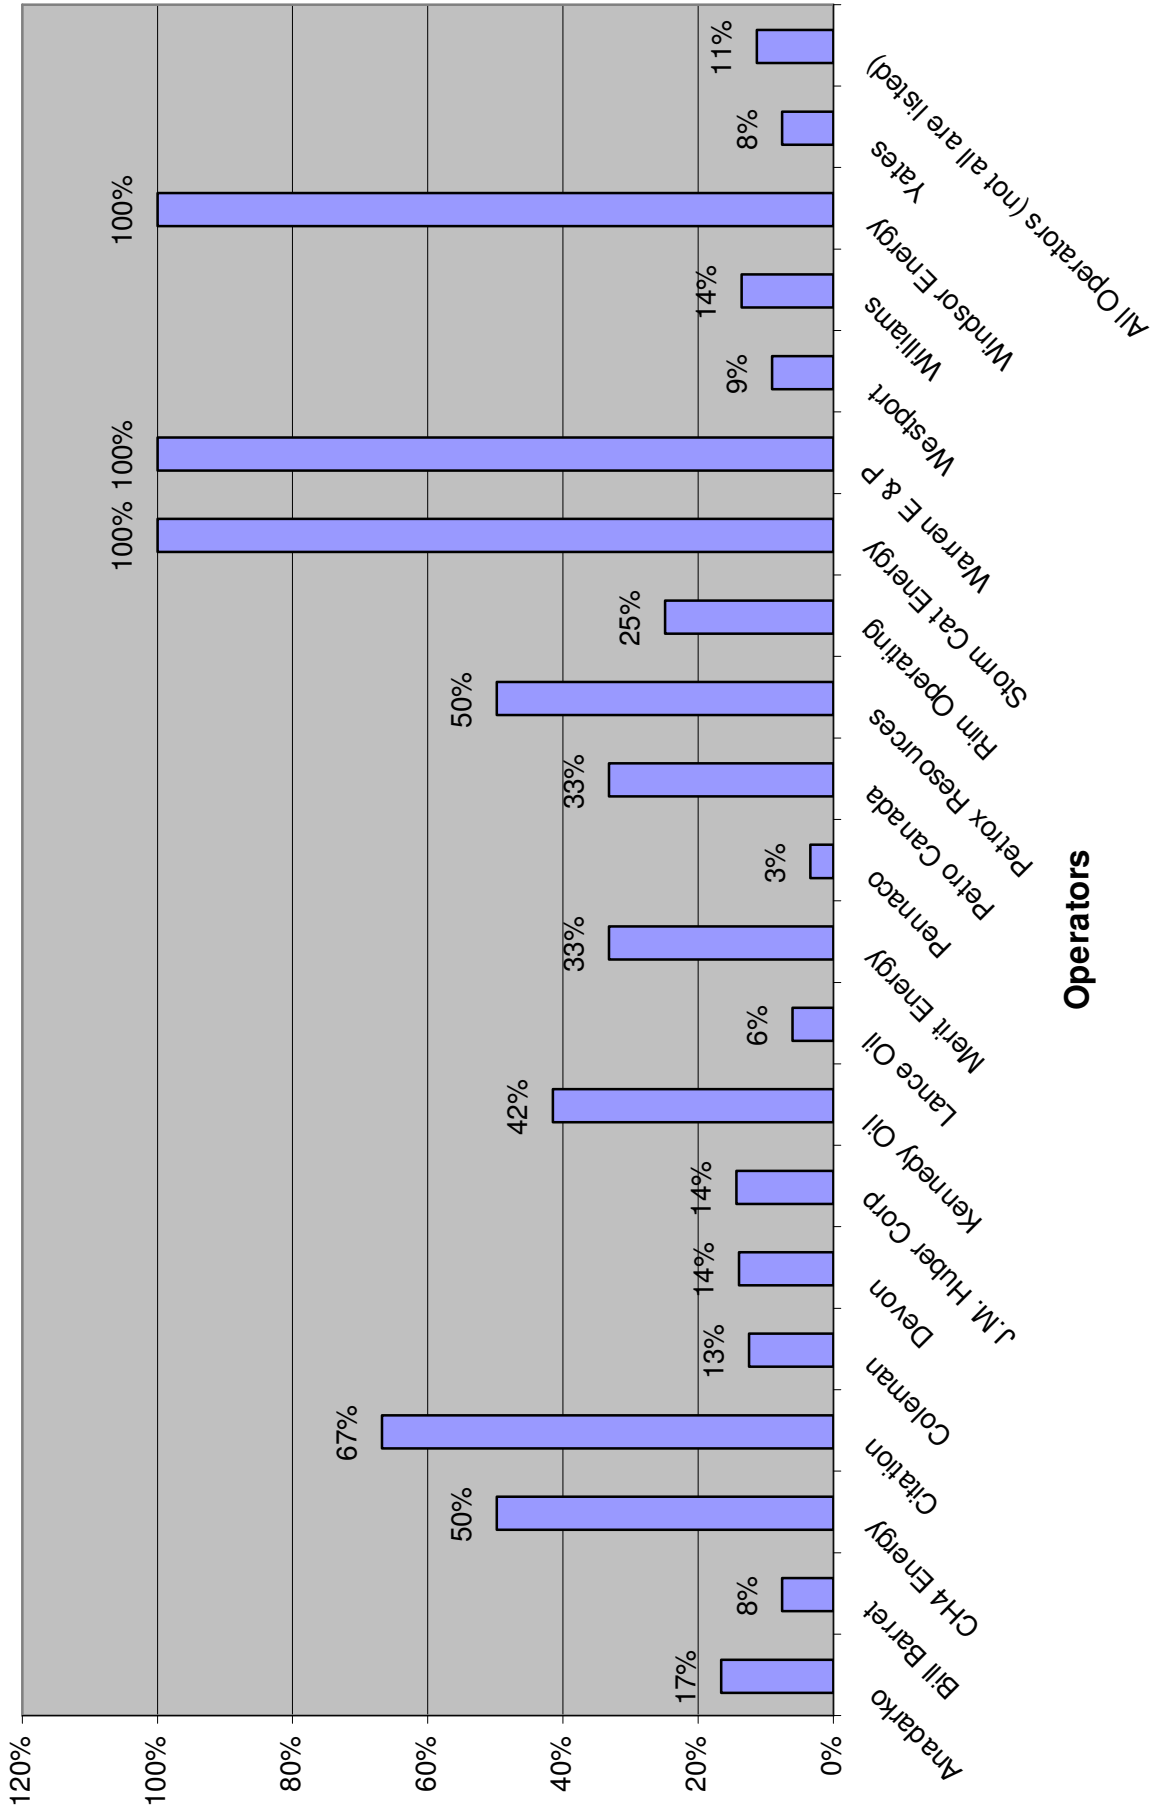
**Figure 7: Percent of PODs Inspected vs. PODs Approved**

Just 6 of the inspected operators had 50% or more of their PODs inspected, and 3 were 100% inspected (Figure 7). However, 10 operators had less than 20% of their PODs inspected (Figure 7). All but 3 of the large operators, with more than 6 PODs, had inspections completed on at least 1 of their PODs.

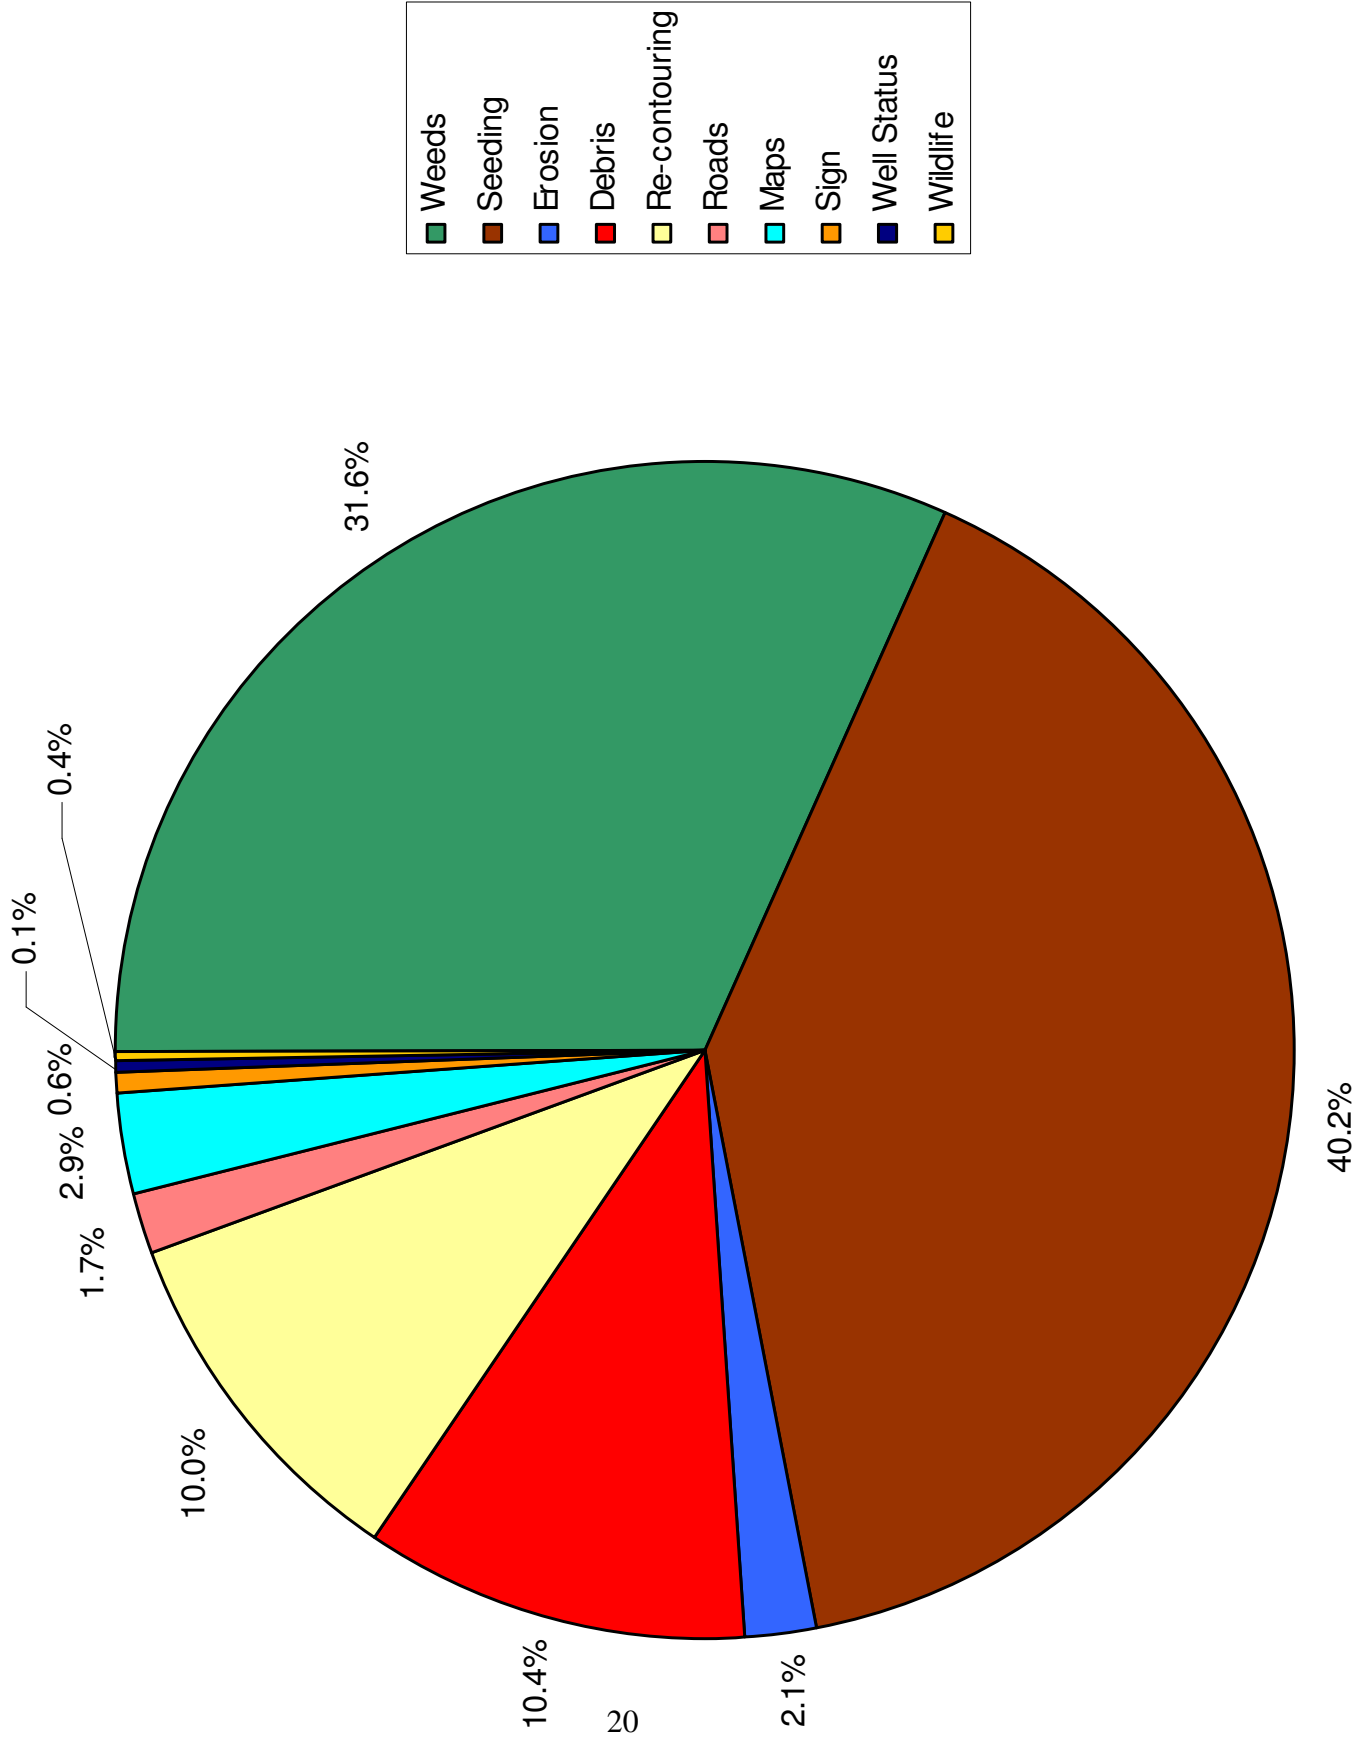
**Figure 9: Percent of Environmental Problems Found**

Written Orders were written for almost every environmental problem found during field inspections. The majority of non-compliance issues addressed by Written Orders are related to the lack of completing reclamation obligations. Well locations and associated infrastructures that have not been seeded or need to be seeded again comprise 40.2% of the environmental problems found. (Figure 9)

Another major area of non-compliance has been an abundance of weeds, both noxious weeds and weeds of concern. Several species of weeds were found but the most common were Russian thistle (*Salsola*), Canada thistle (*Cirsium arvense*), Cheatgrass (*Bromus tectorum*) and Kochia (*Kochia Scoparia*) (Figure 8). Weeds were commonly found at water containment structures, road and pipeline corridors, and production facilities. Most water containment structures have Canada thistle growing on the shoreline, on the embankment, in the drainage leaving the outlet and/or in the area around the outfall. The well pads, pipelines and roads have also had an abundant growth of weeds. Locations and associated infrastructures inspected that have these weed issues make up 31.6% of problems found. (Figure 9)

Erosion concerns, mostly due to lack of vegetation was 2.1% of problems found. Roads have been another issue that has come up; 1.7% of problems found are roads that have erosion issues, are of an unapproved type, or are different on the ground from what is shown on current inspector maps. Debris on well sites, including wire spools, pipes,

drilling rods, fencing materials and wire, have been found on several sites (10.4% of all problems). Surface re-contouring of well locations, pipelines and roads, as well as spreading topsoil piles has been another issue that was found (10.0% of all problems). Issues related to incorrect or outdated maps were found to be a problem 2.9% of the time. Sign placement (0.6%), status of well (0.1%), and wildlife issues (0.4%) were the least reported problems encountered in the field. (Figure 9)

To address seeding of disturbed locations, or lack thereof, a reactive/end-of-pipe approach should be considered. Implementing an administrative and operational procedure, where the operator notifies the BLM of seeding dates, techniques and seed mix used, as well as provides financial and visual evidence of seeding activity, could help improve the execution of this important stage in the reclamation process. This method will also help keep better records for future field-based evaluations of effective vegetation growth and reclamation success. This procedure will make the operator feel more inclined to actually do the seeding by the required date, since they will have to have a documented date of seeding on file.

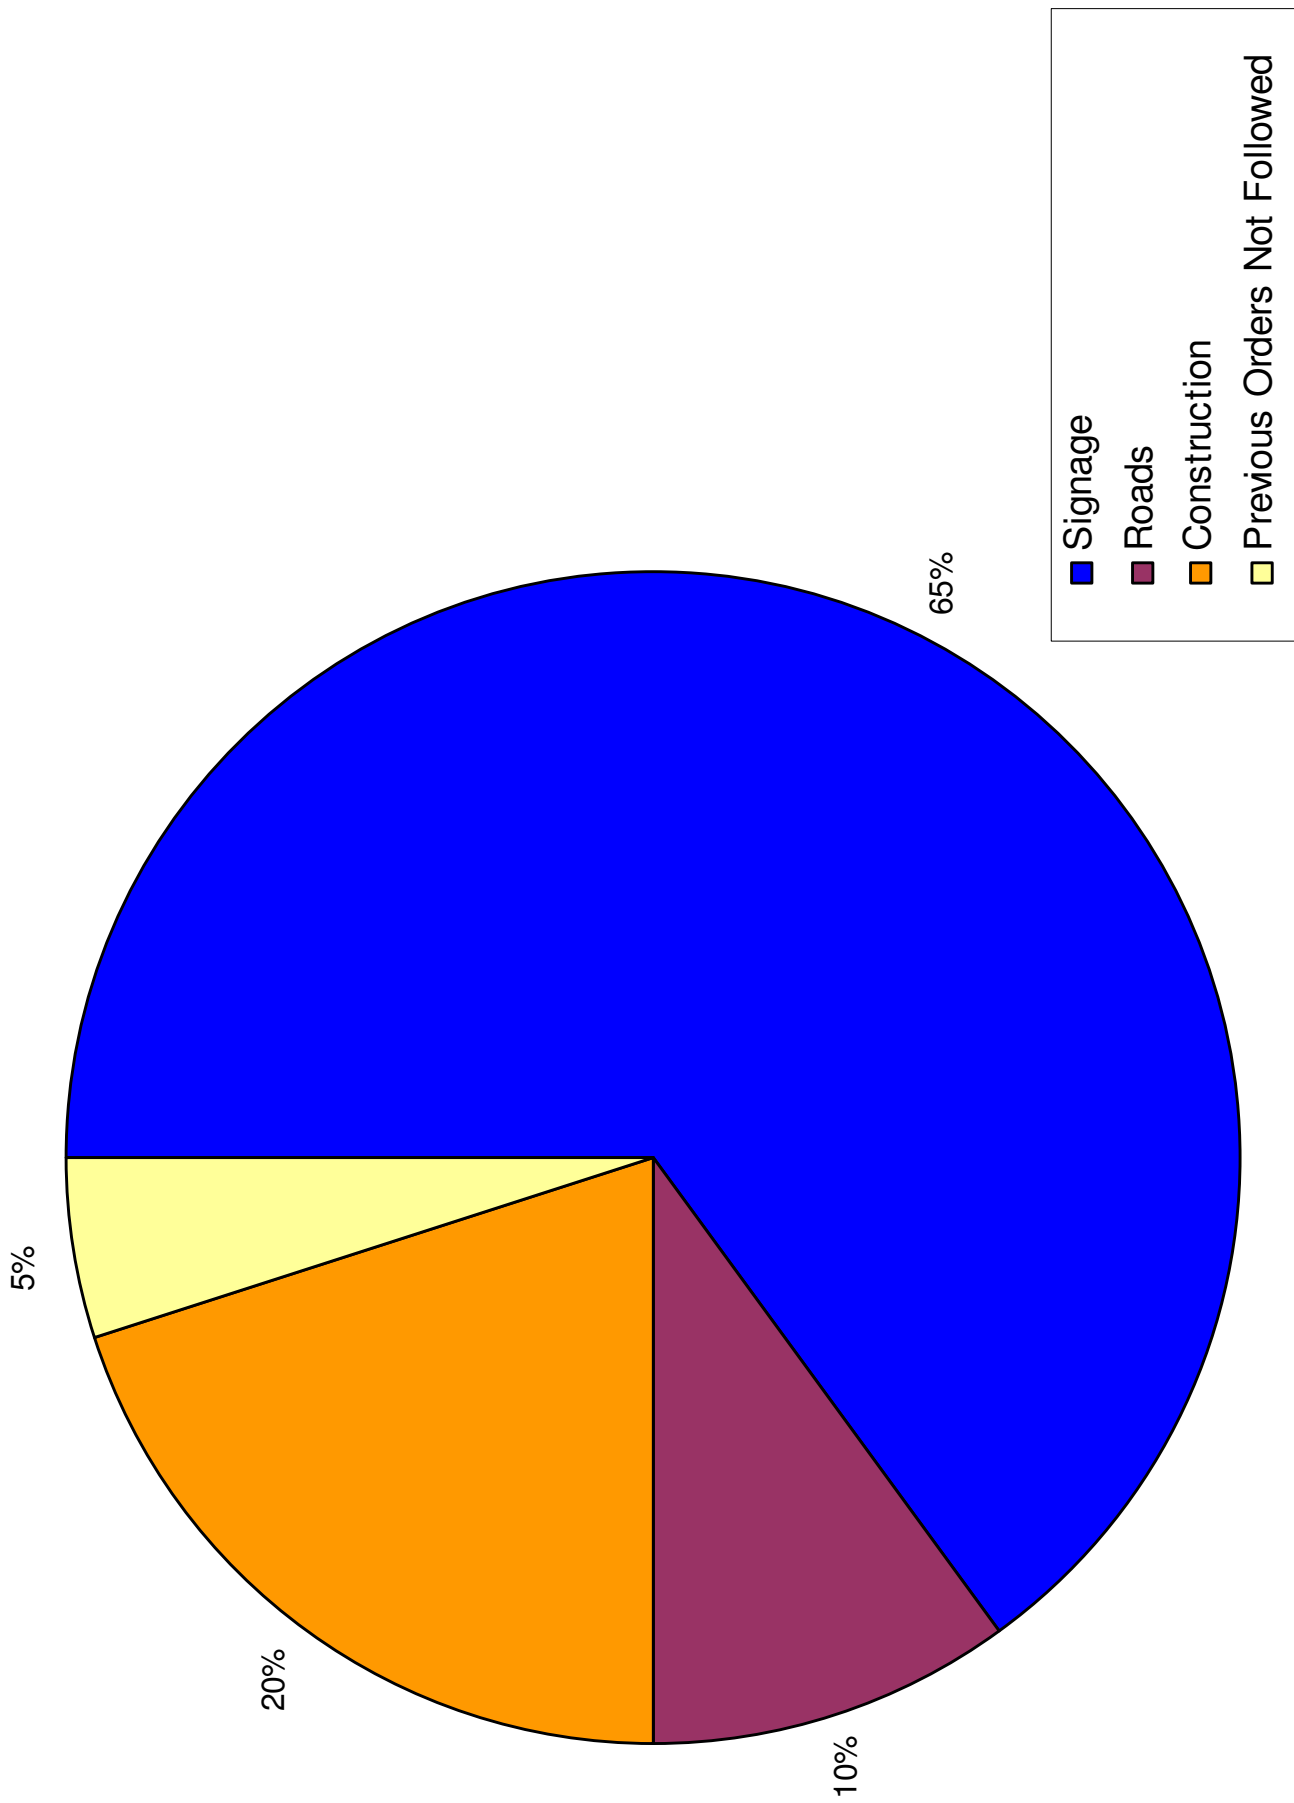
**Figure 10: Incidents of Non-Compliance Letters: Percentage of Offenses**

INC letters were sent to operators for not complying with the approved Surface Use Plan, COAs and/or the Code of Federal Regulations. Of the INC letters that were sent 65% of incidents were for signage, 10% for roads, 20% for construction, and 5% for previous orders not followed. Signage issues were mostly a missing or incorrect sign. Road issues were mostly related to the unapproved type of road; i.e. Crown and Ditch road versus two-track road, or if the road was in the wrong location. Construction issues were for incorrect pad size or constructing a pad that was not approved. (Figure 10)
